Shawsheen River Restoration Interim Feasibility Report (30% Design)

October 14, 2009

Shawsheen River Restoration – Interim Feasibility Report

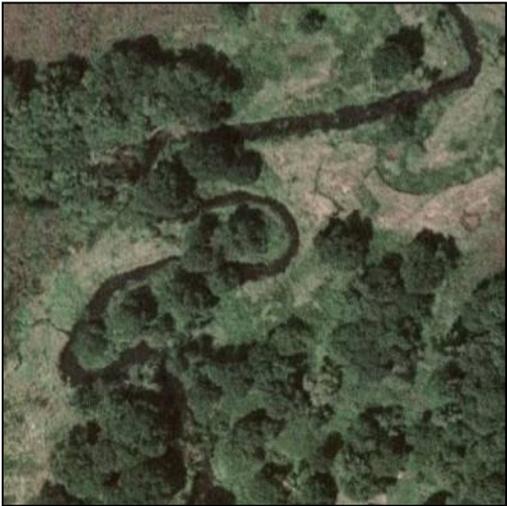
Figure 1. Remnant meander bends on the Shawsheen River

approximately 1 mile downstream of Balmoral, the channel slope is less than .001%, typical of deep, steep banked wetland or tidal rivers. Historically, this channel would have been a groundwater dominated, cool-coldwater stream with a wide, regularly inundated floodplain forest. Such a system has a characteristically deep channel with steep banks and high sinuosity. Remnants of this type of channel are still present where floodplain filling has not occurred (Figure 1)

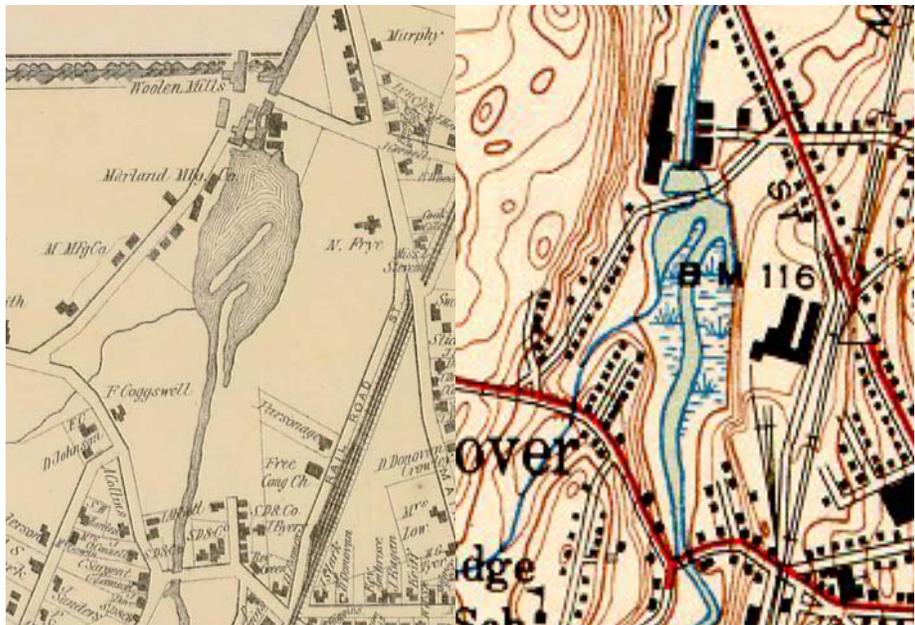
Figure 2. Comparison of Marland Place impoundment depicted in maps from 1872 (left)

As the Marland Place and Ballardvale Dams degraded over time, regular maintenance schedules relaxed, and spillways were modified, their impoundment levels dropped. Changes in normal pool elevation can be observed by comparing historic maps and aerial photographs (for Marland Place see Figure 2 and for Ballardvale see Figure 3).

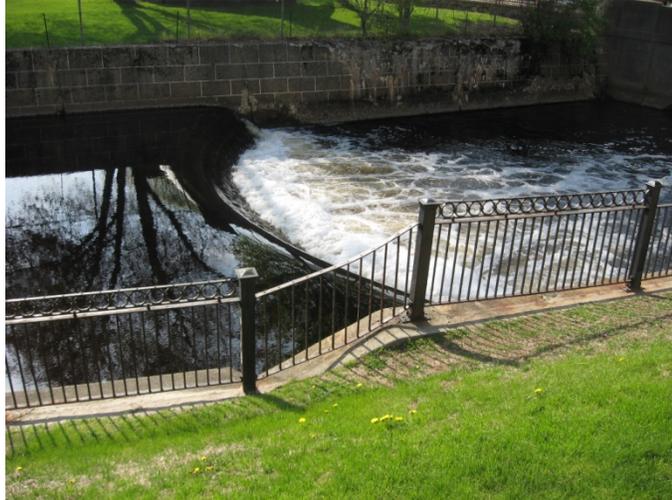
Figure 4. Balmoral Dam looking west toward the Bowling Green

The Balmoral Dam is a solid concrete dam with a stepped arch spillway height of 6.8 ft spanning 50 feet between confining concrete walls (Figure 4). The spillway is a stepped profile with seven (7) drops of 1-ft each spaced 18 inches apart (1.5H : 1.0V – See Figure 5). just downstream of Balmoral Street in Andover, MA. Existing Flood Insurance Study (FIS) and project hydraulic modeling information shows that low flow backwater conditions persist to approximately 1500 feet downstream of the Marland Place dam (4300 feet upstream, 4.0 acres). During the 10-year flood, as modeled in the FIS, water backs up to the Marland Place Dam. It is assumed that the dam has some impact on upstream groundwater and wetland conditions up to the Marland Place Dam.

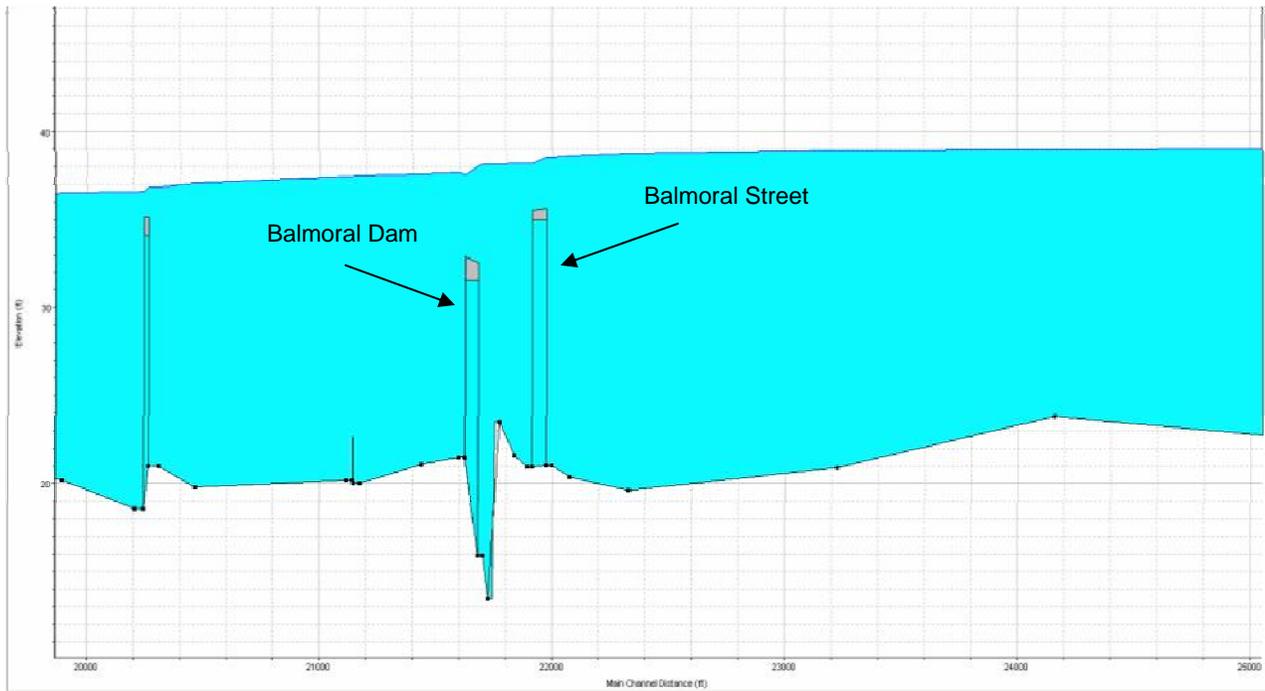
Figure 6 – This hydraulic model output shows the river flowing right to left. The channel bottom is the black line under the blue shaded area. The blue shaded area is the Shawsheen River level during the 100-year flood. The water elevation during this flood is 2-3 feet above Balmoral Street and 5-6 feet above the dam crest. The effect of the Balmoral Dam on large flooding is minimal.

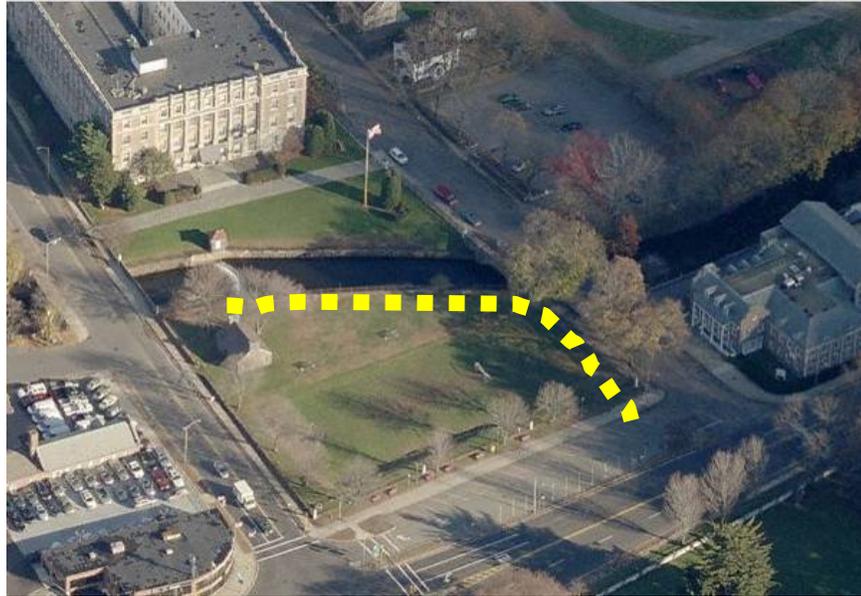
Figure 7. Primary access route proposed for ingress and egress of heavy equipment for the removal of the Balmoral Dam.

Notes on the 30% Plansheets – The 30% plansheets show a simple dam in versus dam out drawing. Site access is good at the Balmoral dam site, although some temporary access ramps may need to be installed to protect historic walls along access points from Main Street or Balmoral Street. Equipment could stage in the Bowling Green area, with any disturbance being restored after completion of the project (Figure 7). This could be an opportunity to both serve the project and provide needed reseeded of the Green. The left bank concrete wall could be cut down 4-5 feet to allow for temporary access. A construction pad of porous cobble or concrete box culverts could be installed to minimize equipment contact with the active channel. The dam would be notched and flow concentrated into a small breach. If the flume along the right bank is operable, this could also be used to help dewater the dam site. Once

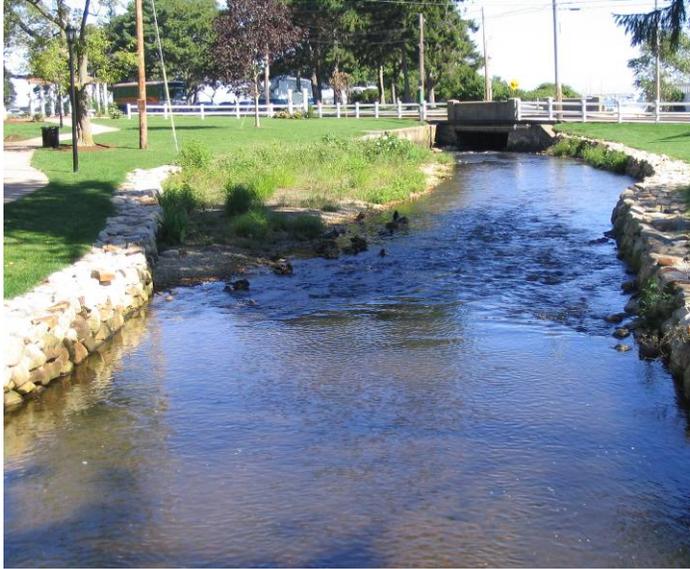
Figure 8. Constructed riffle on Town Brook, Plymouth

The plansheets show a cobble and boulder riffle installed at the dam location. The dam has acted as a grade control for many years, although there appears to be no significant incision occurring at the downstream face. Replacing the dam with a stable riffle will prevent the upstream migration of any incision caused by changes in bed elevation downstream. These changes could be caused by replacement of the Haverhill or Balmoral Street bridges, changes to the railroad berm downstream or other hydraulic controls. It is a prudent measure in a confined channel with concentrated flood flows that could cause post-removal scour. The riffle proposed would only have a crest elevation 1-1.5 feet higher than the existing bed (slope <1.0%), and so would appear to be a submerged riffle passable by canoes and kayaks. The site is currently a popular viewing area for people watching smelt and herring attempt to jump over the dam. An installed riffle will continue to concentrate people and allow them to experience first hand successful fish migration. Interpretive signs could be placed to educate the public about the benefits of dam removal. The installed riffle would have an appearance similar to the riffle shown in Figure 8, installed by Inter-Fluve to control grade and provide habitat in Town Brook, Plymouth, MA.

Our concept design plan suggests the construction of a grade controlling riffle structure. This riffle would appear similar to that shown in Figure 8. The dam has acted as a grade control and has created hydraulic backwater through the Stevens Street crossing for many years, limiting scour. Replacing the dam with a stable riffle will prevent the upstream migration of any incision caused by changes in bed elevation downstream. Riffle construction and other habitat construction is often part of post-removal, and in this case will not impound sediment. These changes could be caused by replacement of the Main Street bridge, removal of the Balmoral Dam (changing hydraulics), or other hydraulic controls. It is a prudent measure to prevent excessive scour or bed degradation in an area with a high density of infrastructure, upstream bridges and confined flood flows. The riffle proposed would only have a crest elevation 1-1.5 feet higher than the existing bed (slope <1.0%), and so would appear as a submerged riffle. The riffle will be passable by canoes and kayaks.

Our concept design plan suggests the construction of a grade controlling riffle structure. This riffle would appear similar to that shown in Figure 8. The dam acts as a grade control and has created hydraulic backwater through the Andover Street crossing, limiting scour. Replacing the dam with a stable riffle will prevent the upstream migration of any incision caused by changes in bed elevation downstream. It is a prudent measure in an area with adjacent buildings, parking lots and a major road crossing. The riffle proposed would only have a crest elevation 1-1.5 feet higher than the existing bed (slope <1.0%). The riffle will be passable as a Class I rapid by canoes and kayaks except during low flows. We believe that this riffle would be a natural feature and a welcome change from the existing aesthetic, particularly during low flow (see Figure 13).

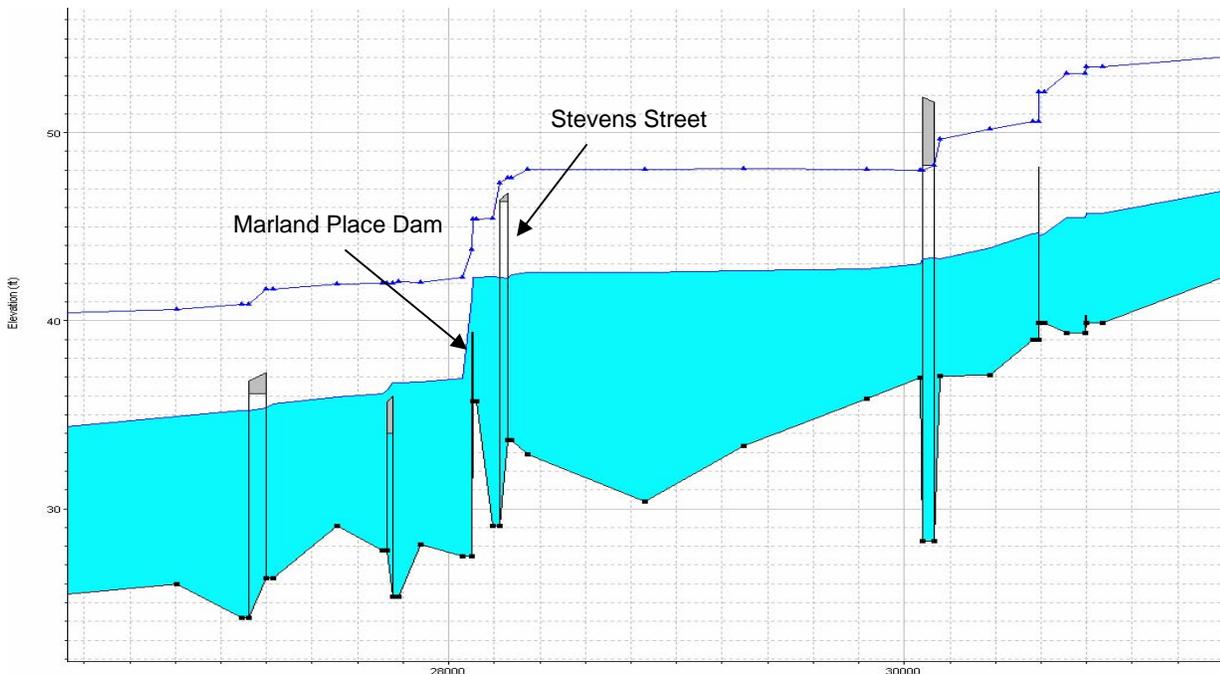
The water level in the Marland Place Dam has no flood control benefit. Analysis of FEMA flood profiles (FEMA 1993, URS 2008) and HEC-RAS generated flood profiles suggests that the Marland Place Dam does contribute significantly to increased water levels upstream to Essex Street. This effect is visible for both small and large events up to at least the 500-year flood (Figure 9).

Figure 9 – This hydraulic model output shows the river flowing right to left. The channel bottom is the black line under the blue shaded area. The blue shaded area is the Shawsheen River level during the 2-year flood. The blue line above is the 500-year flood elevation. These preliminary results show that the Marland Place Dam does cause a 5 ft rise in upstream flood elevations for the 2-year flood, and a 2-3 foot rise in the 500-year flood. Removal in this case would help to decrease upstream flood levels.

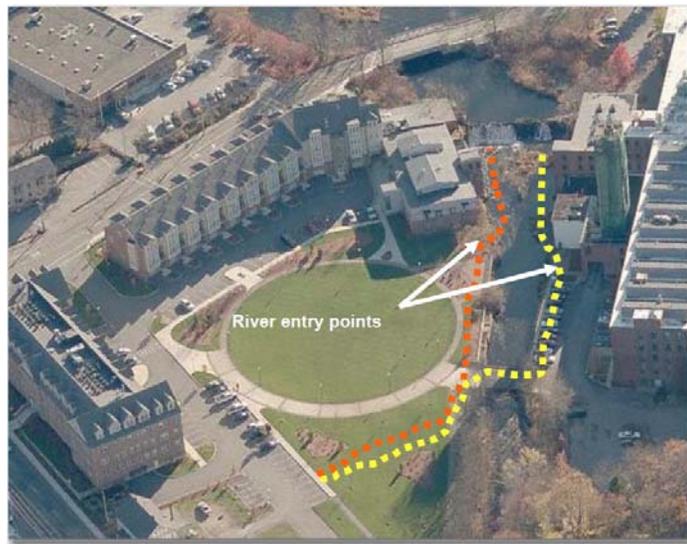
Figure 10. Potential primary (orange) and secondary (yellow) access for the Marland Place Dam removal. White arrows indicate river entry areas requiring temporary access ramp construction.

Notes on the 30% Plansheets – The most practical access to the Marland Place Dam is from the asphalt walk path on the right bank just downstream of the structure (Figure 10). Alternate access could be gained from the parking lot area on the left bank, but this would require heavy equipment crossing the concrete bridge. Any access and staging areas would be repaired to their original pre-construction condition. A construction access pad would need to be constructed along either bank leading up to the structure. The access pad may not need to be extensive, as the channel has a gravel

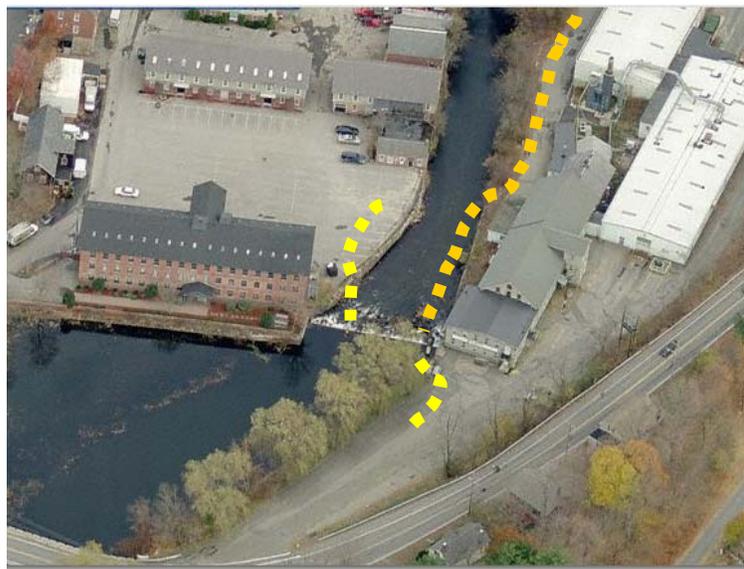
Figure 12. Primary (orange) and secondary (yellow) access routes for construction at the Ballardvale Dam site

Notes on the 30% Plansheets – The most practical access to the Ballardvale Dam is from the rear of the right bank buildings (Shawsheen Coating and Converting). Adequate staging area can be found along the road behind the buildings. Additional alternative access could be gained from the right bank

upstream of the dam, and from the parking lot on the left bank downstream of the dam (Figure 12). Any access and staging areas would be repaired to their original pre-construction condition. A construction access pad would need to be constructed along either bank leading up to the structure.

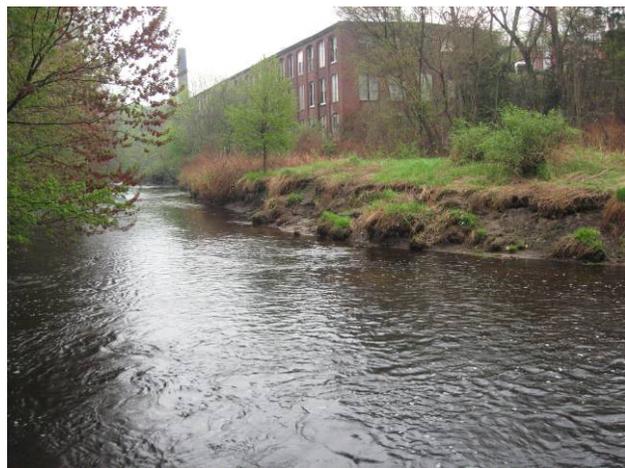
Figure 14. Former impoundment sediment exposed after failure and partial removal of the Redman Cloth Dam on the Shawsheen River (photo 2008)

Interviews with watershed residents and the current occupants of the Redman Card Clothing Company (Red Rocks) Dam suggest that the dam was breached sometime around 1973, and the structure was further eroded following the 2006 flood (URS 2008). A rock riffle remnant of the dam still remains, and impounds water a few hundred feet upstream. Exposed banks in legacy sediments upstream clearly show the sedimentation patterns and erosion typical of a rapid drawdown removal (Figure 14). A significant amount of the Marland Place dam sediment may have come from this removal. The floodplain upstream also demonstrates the slow recovery of floodplain conditions in legacy sediments. Reed canarygrass dominates the floodplain and is preventing woody species from colonizing the area.

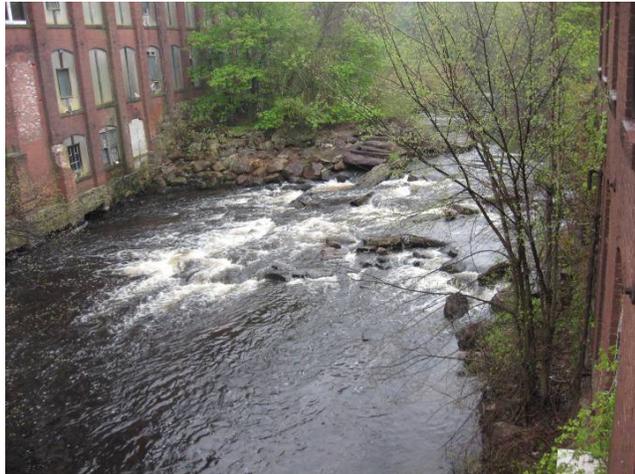
Figure 15. Remnant of the Red Rocks Dam

The current rock riffle is steep and presents a navigation hazard to boaters (Figure 15). According to local recreationists, the rock riffle is a safety hazard for two reasons; segments of the dam are blocking the channel, and the hydraulics tend to guide boats toward an old powerhouse sluiceway under the right bank building. We recommend blockage of the sluiceway, removal of an additional 8-15 feet of remnant dam and reconstruction of the riffle remnant to improve fish passage and canoe conditions. Riffle reconfiguration could be accomplished with a medium-sized excavator (eg. CAT 315) equipped with a hydraulic thumb. Individual stones could be moved and placed to direct water into a more gradual slope. Riffle reconfiguration would likely require importing 25-50 cubic yards of boulders and cobbles. Additional riparian restoration could include grading of impoundment area bank slopes, peeling of reed canarygrass dominated soils, placement of topsoil and planting with native riparian tree species. Restoration and replanting

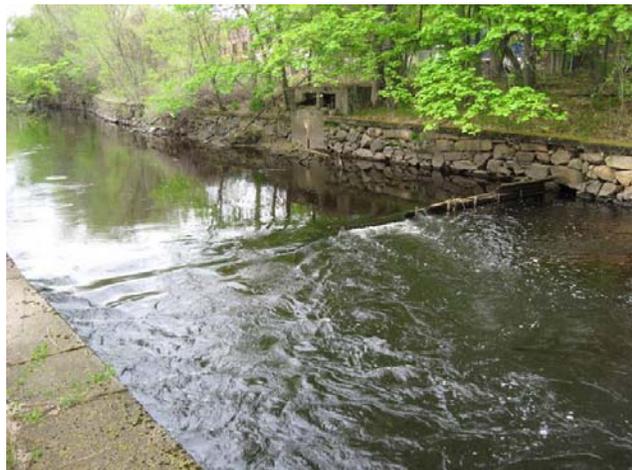
Figure 16. Remnant of the Unnamed Dam downstream of Haverhill Street (photo 2008).

The unnamed dam is 613 feet downstream of the Balmoral dam. All that remains of this dam are 1-2 feet of boards held in place by rebar rods (Figure 16). There is no significant sediment deposit upstream of this dam. The dam remnant is a hazard to paddlers and may pose an obstruction to migratory fish under low flow conditions. We recommend removal of the boards and rebar using manual labor. No other work is necessary at this site.
